1. AGENCY USE ONLY (Leave blank)		2. REPORT DATE June 1994		3. REPORT TYPE AND DATES COVERED Final Report
4. TITLE AND SUBTITLE Metallurgical Examination of Failed T-158 Cast Austempered Ductile Iron (CADI) Track Shoes			5. FUNDING NUMBERS

6. AUTHOR(S) V. Champagne, M. Pepi, B. Pothier, D. J. Snoha, G. Wechsler, and M. G. H. Wells				
7. PERFORMING ORGANIZATION NAME(S) AND ADDRESS(ES) U.S. Army Research Laboratory Watertown, MA 02172-0001 ATTN: AMSRL-MA-CB			8. PERFORMING ORGANIZATION REPORT NUMBER  ARL-TR-451

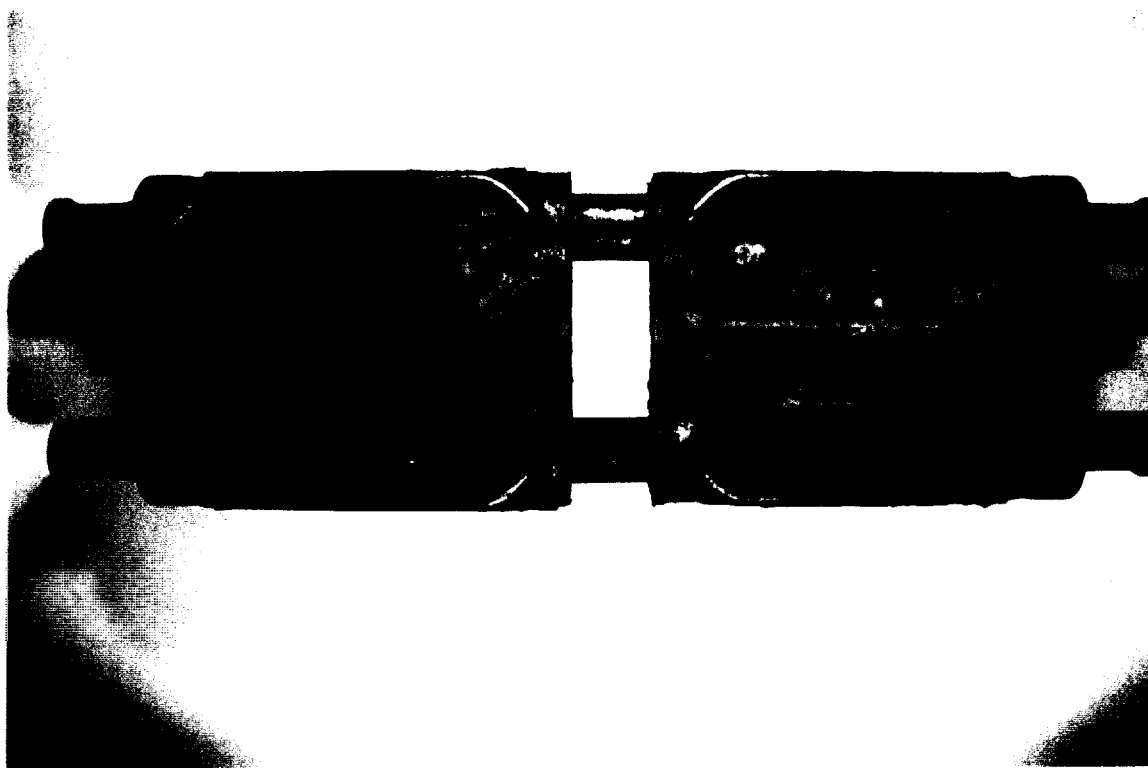
After several months, two of the seven failed CADI track shoe bodies (Ft. Greely) were sent to the U.S. Army Research Laboratory-Materials Directorate (USARL-MD), Watertown, Massachusetts, for post-service analysis. Figures 1 and 2 show both of these track shoes in the as-received condition. Figure 1 shows Track #L30 (Ft. Greely designation stamped into shoe), while Figure 2 shows Track #R6 (also Ft. Greely designation). Track #L30 travelled 59 kilometers before failure, while Track #R6 travelled 1239 kilometers before failure.

FIGURE 1 Failed track shoe #L30 in the as received condition. Reduced 80 %

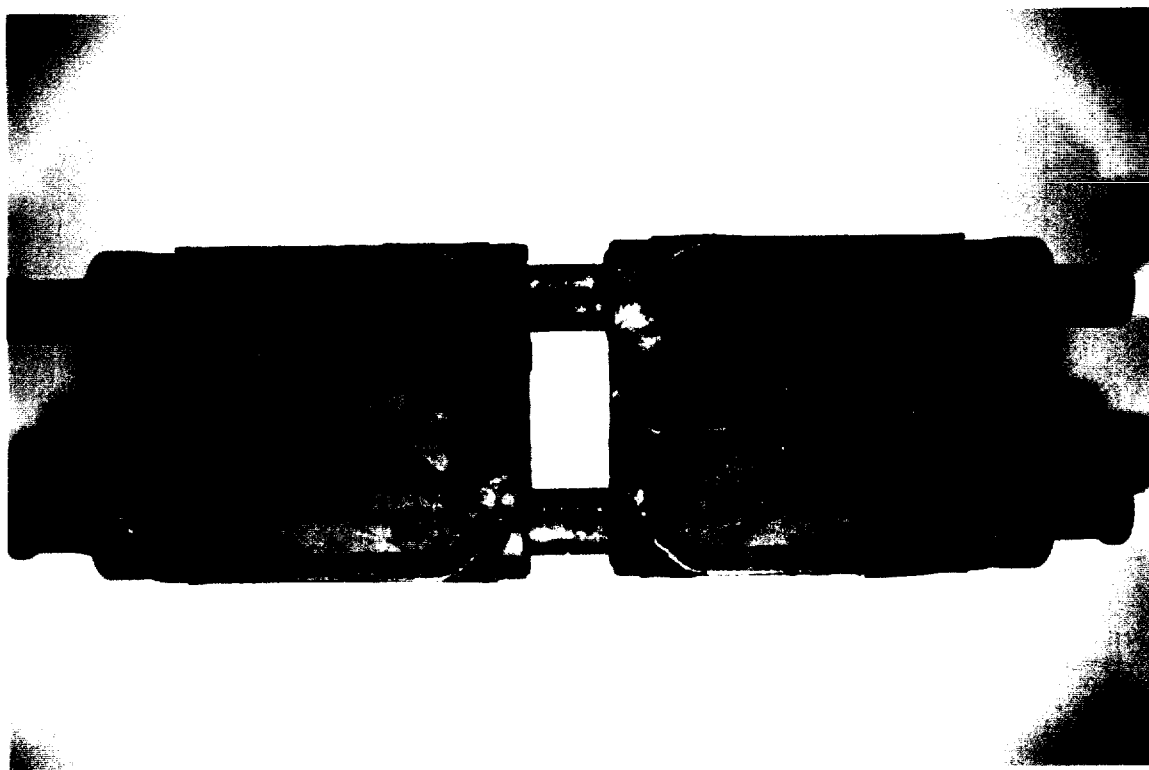
FIGURE 2 Failed track shoe #R6 in the as-received condition. Reduced 80%

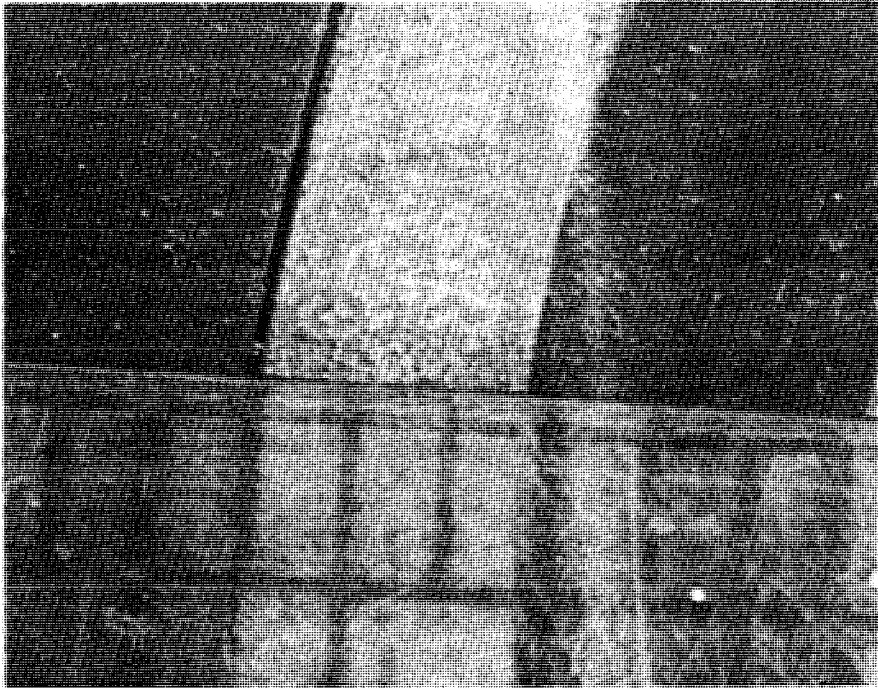
Again, this is the same minimum allowable thickness noted on TACOM Engineering Drawing No. 12348383 for a *forged* component. Since the thickness varied around the diameter of the tube, macrographs were taken of a representative cross section showing the area of minimum thickness and the ground side thickness for Track #R6. Figure 5 shows the area of minimum thickness of track shoe #R6, while Figure 6 shows the thickness at the ground side. The thickness of these regions was measured directly from the photomicrographs, at a magnification of 10x. The thickness results are listed in Table 1, as well as the minimum allowable criteria from TACOM drawing No. 12348383.

FIGURE 5 Macrograph showing area of minimum thickness on the binocular tube of track shoe #R6. Mag. 10x. (Scale in millimeters).

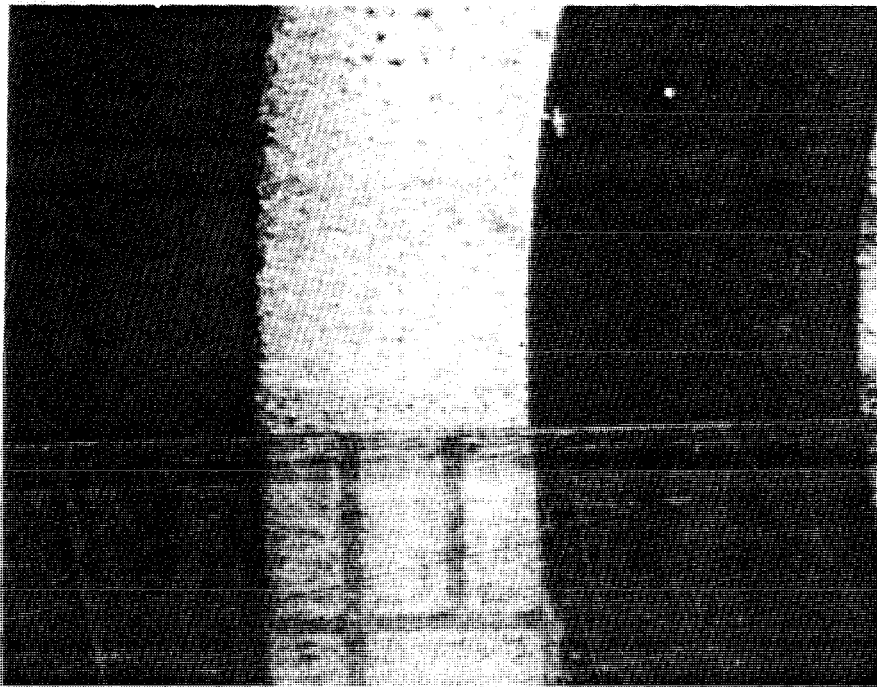
FIGURE 6 Macrograph showing thickness of the #R6 binocular tube on the ground side. Mag. 10x. (Scale in millimeters).

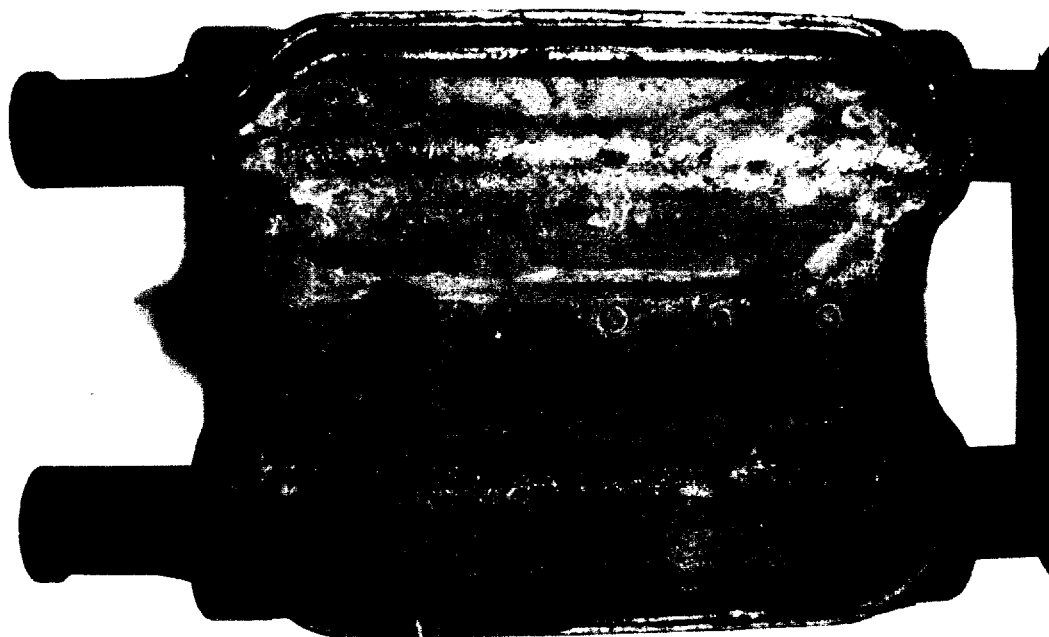
Figure 7 shows the failed half of the track shoe. The location of the crack was on the ground side. The track shoe was sectioned in order to examine the fracture surfaces, as shown schematically in Figure 8. These fracture surfaces were labelled A, B, C and D for identification purposes. Each fracture surface was covered with a vast amount of corrosion products, indicating a prolonged exposure to the environment. Figure 9 shows fracture faces A and B respectively. Fracture face C is shown in Figure 10, while fracture face D is shown in Figure 11. Although the fracture faces were covered with corrosion, fractographic features were still discernable. The chevron patterns and river markings of each fracture surface indicated the fracture initiated at the bolt hole (ground side). Figure 12 shows a magnified view of the crack through the bolt hole region (ground side). This hole is utilized to attach the ice cleat to the track shoe. Figure 13 shows a magnified view of the underside of the cracked bolt hole region (wheel side). This hole was examined, in order to reveal anomalies which may have contributed to crack initiation. It was noted that the top 1/16 inch of this hole contained what appeared to be a start of a thread (Figure 12). The TACOM drawing for a forged component does not require this bolt hole to contain threads or a chamfer, as it is solely a through-hole. Figure 14 shows the comparison between the bolt hole of track shoe #R6 and that of track shoe #L30. The bolt hole of track shoe #R6 contained no such markings. In addition, significant wear was noted on the underside of the hole, most likely the result of a washer or bolt head. Magnetic particle inspection was performed on this hole to reveal possible evidence of cracking. Figure 15 is a blacklight photograph showing the wear, as well as a crack (as denoted by the arrow). Figure 16 is a photomicrograph of the fracture origin, as noted on Fracture Face B. Figure 17 shows an enlargement of the crack origin, as noted on Fracture Face D.

FIGURE 7 Macrograph showing failed half of track shoe #L30. Reduced 60%

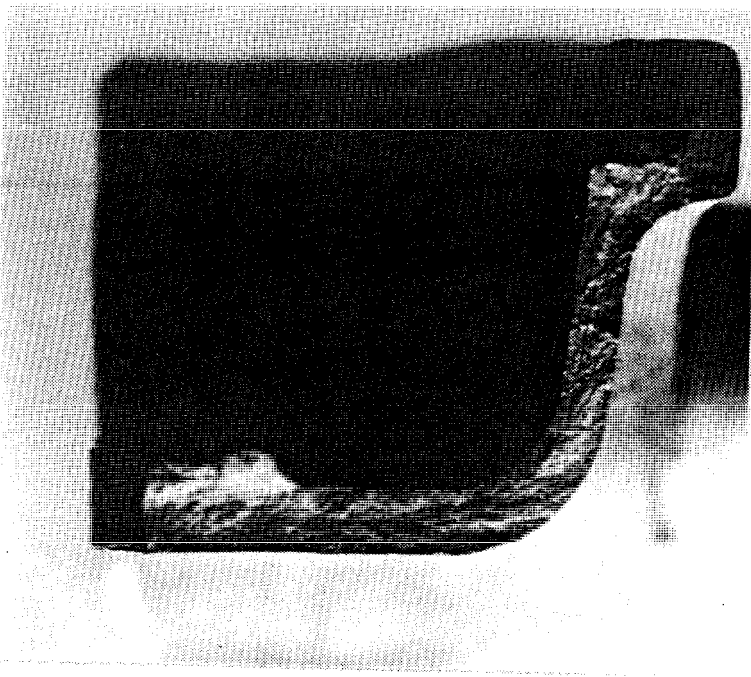
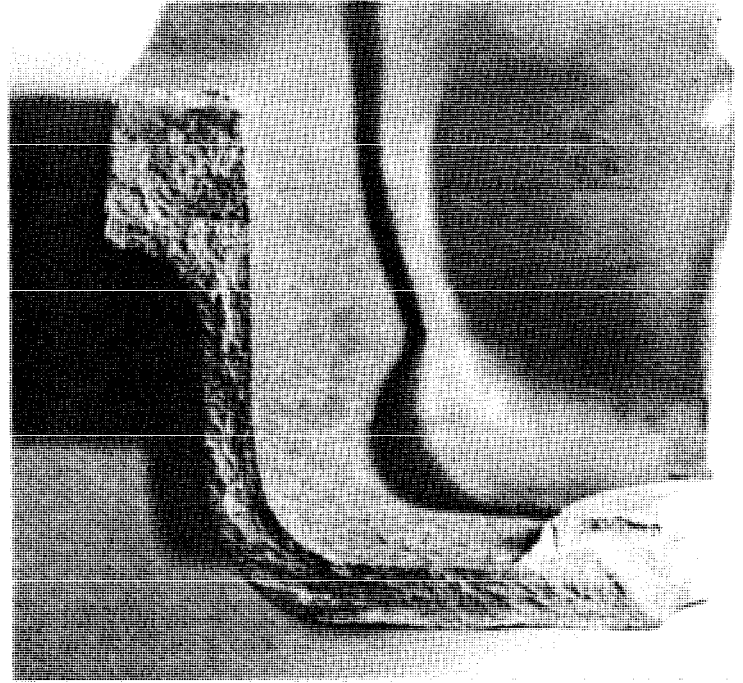
FIGURE 9 Fracture faces A and B, respectively, of track shoe #L30. Chevron pattern converges to ground side of track shoe bolt hole. Mag. 1.25x.

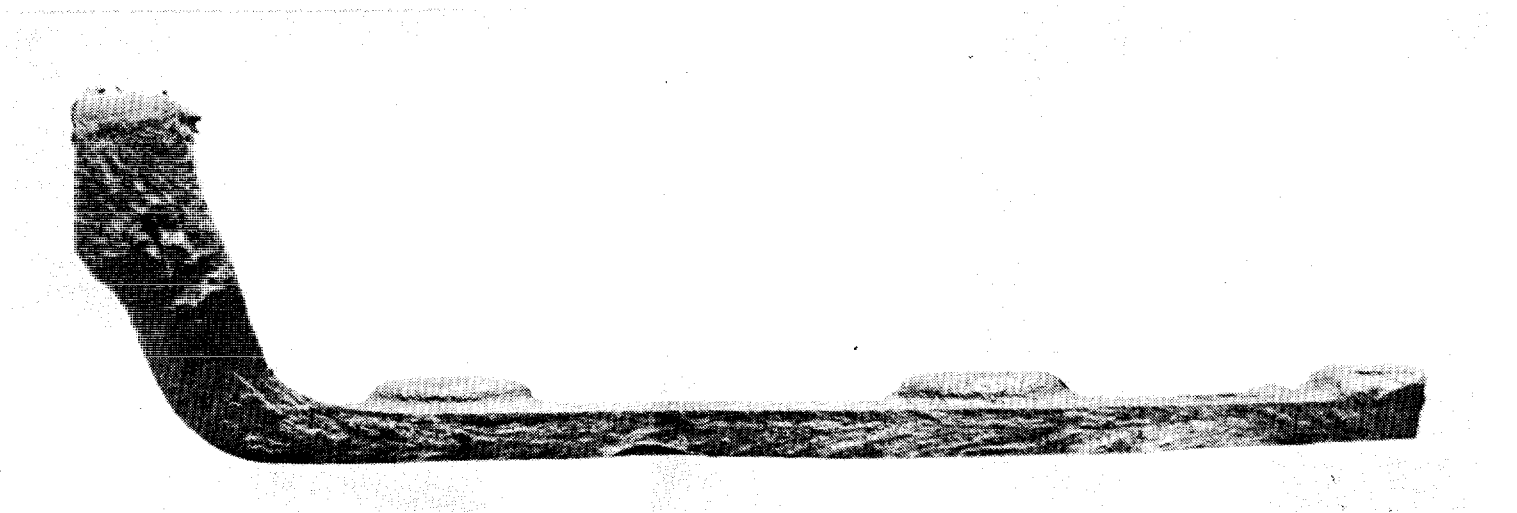
FIGURE 10 Macrograph of Fracture Face C of track shoe #L30. Chevron pattern converges to ground side of track shoe bolt hole. Mag. 1.25x.

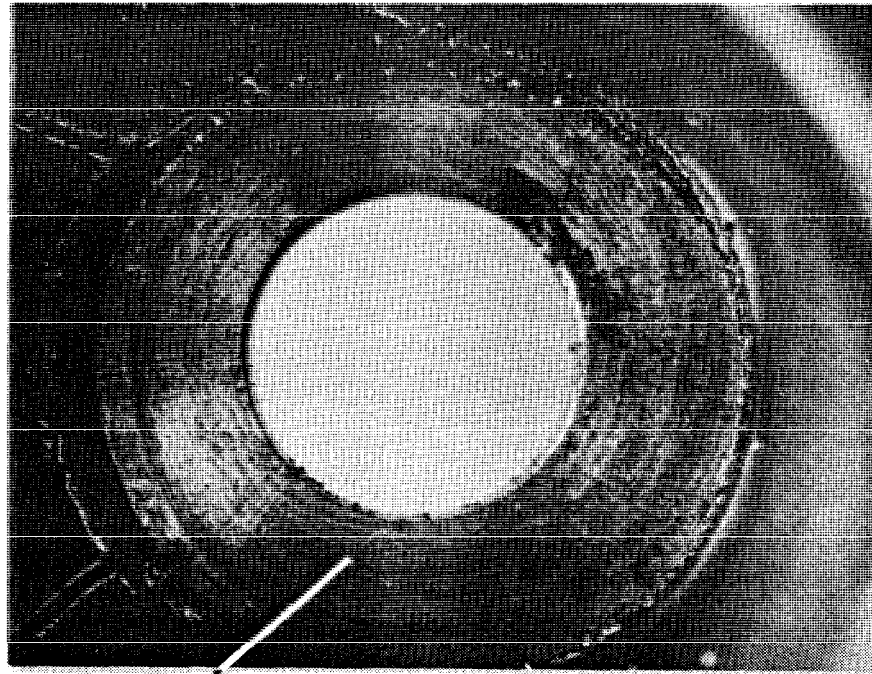
secondary crack

FIGURE 15 Blacklight photograph showing wear on underside of bolt hole. Notice the secondary crack revealed through magnetic particle inspection. Mag. 2x.

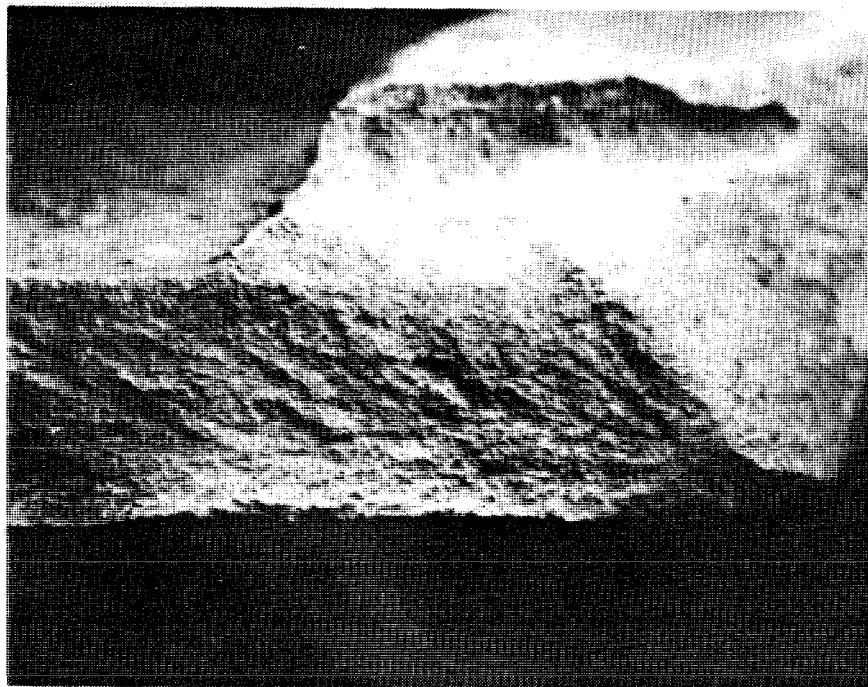
FIGURE 16 Enlargement of the crack origin on Fracture Face B. Mag. 10x.

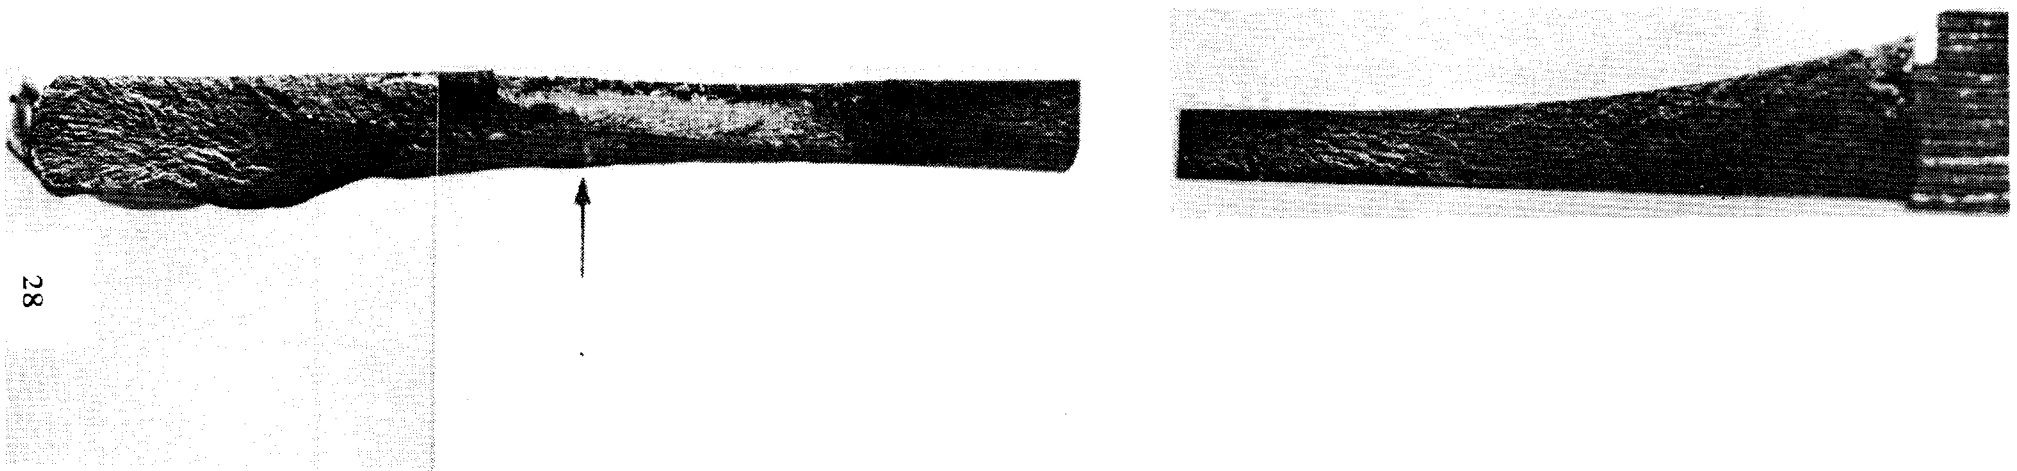
Figure 2. Photo montage showing fracture faces A and C. Arrow indicates fracture origin, as highlighted by chevron patterns and river markings. Mag. 2x.

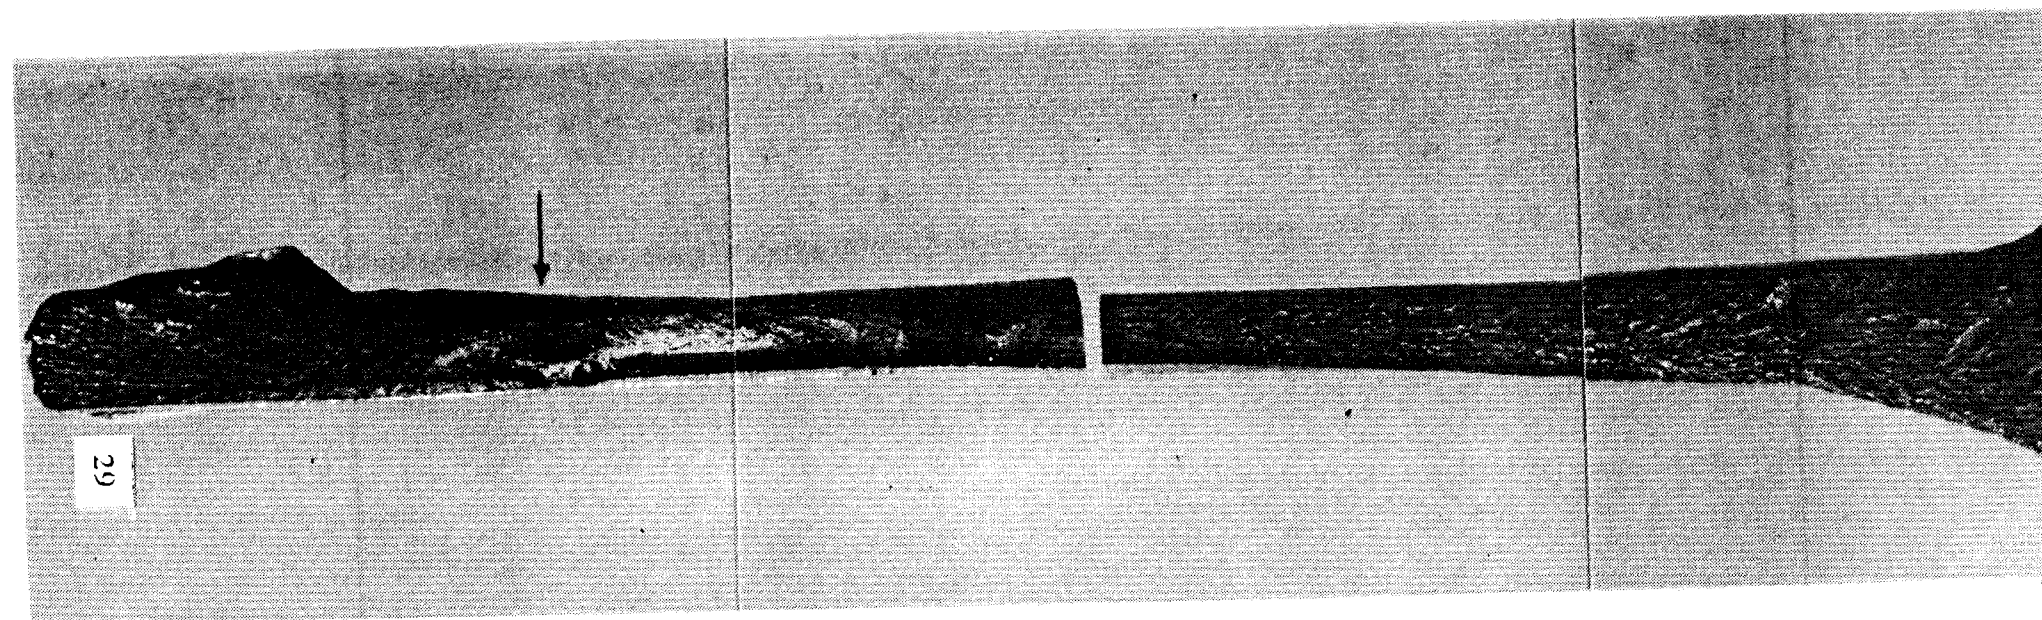
Figure 22 Photo montage showing fracture faces B and D. Arrow indicates fracture origin, as highlighted by chevron patterns and river markings. Mag. 2x.

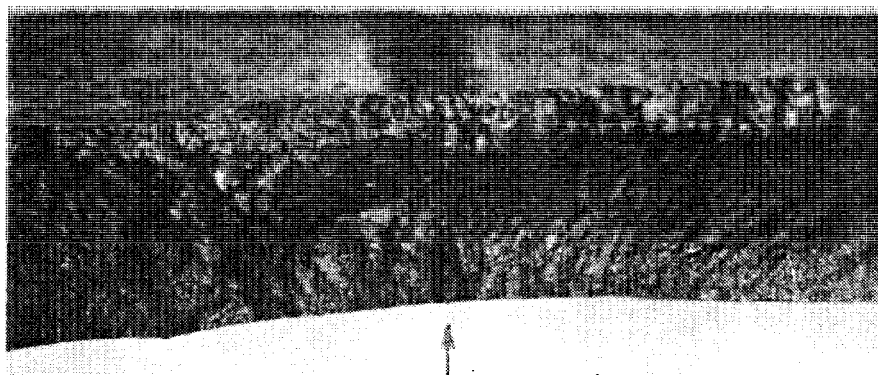
Origin

FIGURE 23 Fracture origin of fracture face A, of track shoe #R6. Mag. 7.5x.

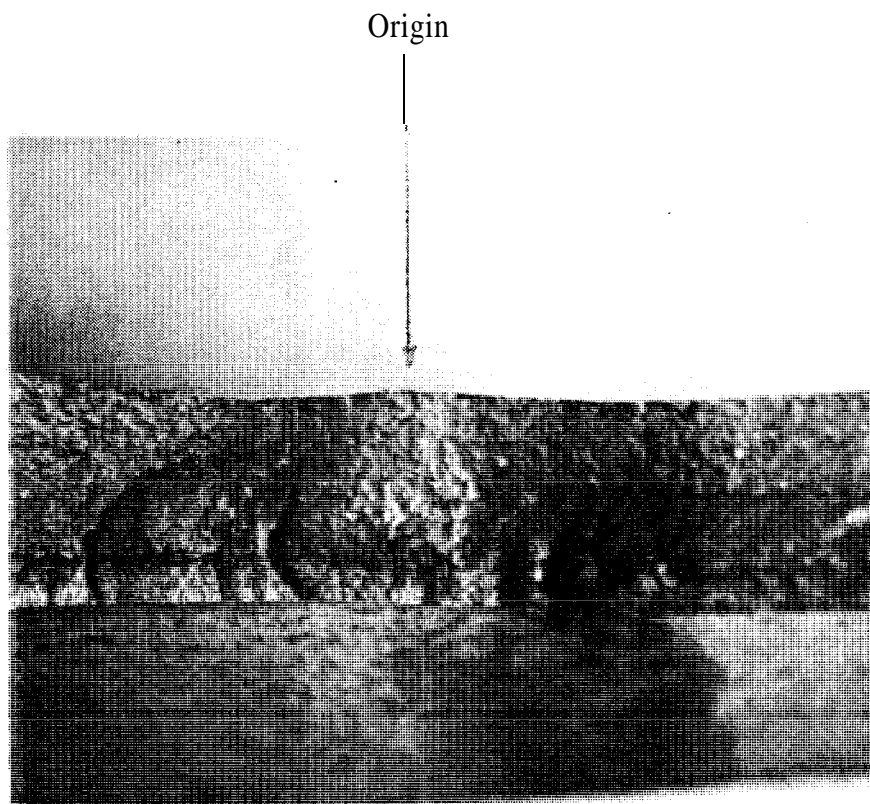
Origin

FIGURE 24 Fracture origin of fracture face B, of track shoe #R6. Mag. 7.5x

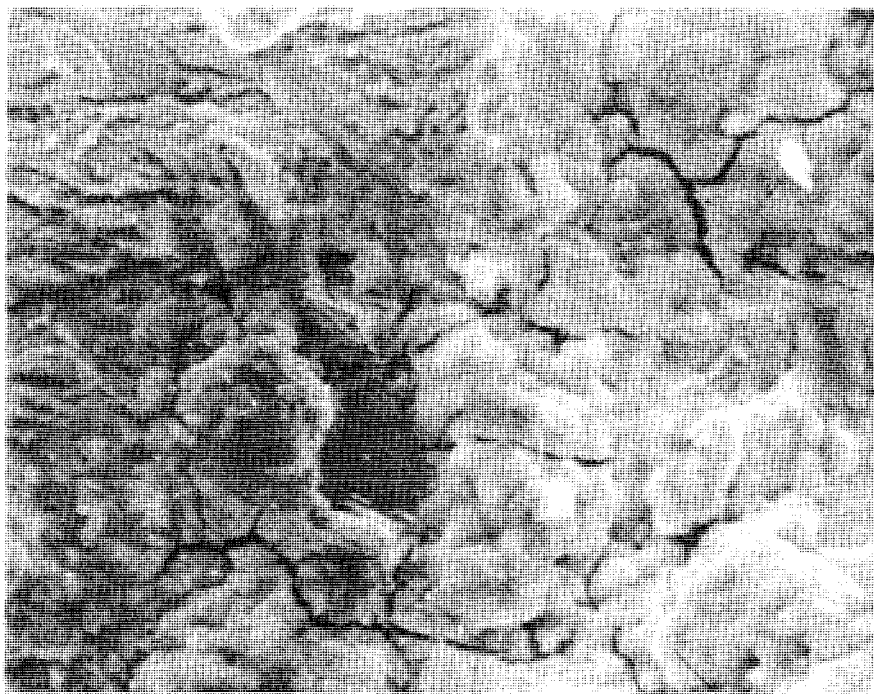
The fracture surfaces of each of the failed track shoes were examined utilizing the scanning electron microscope. Figure 25 shows the difficulty encountered, due to the corroded surfaces. This photomicrograph shows the "mud cracking" feature of the surface. The fracture surface was chemically cleaned, revealing a more discernible morphology. Figure 26 shows the fracture morphology of a less corroded region. Note the craters where the graphite spheroids have been pulled out. The surface appears to have failed in cleavage. Areas of ductile dimples were noted, and are shown in Figures 27 and 28. These dimples are associated with a ductile failure which could occur during overload.

FIGURE 25 SEM of corroded fracture surface showing prevalent “mud-cracking”. Mag. 2500x.

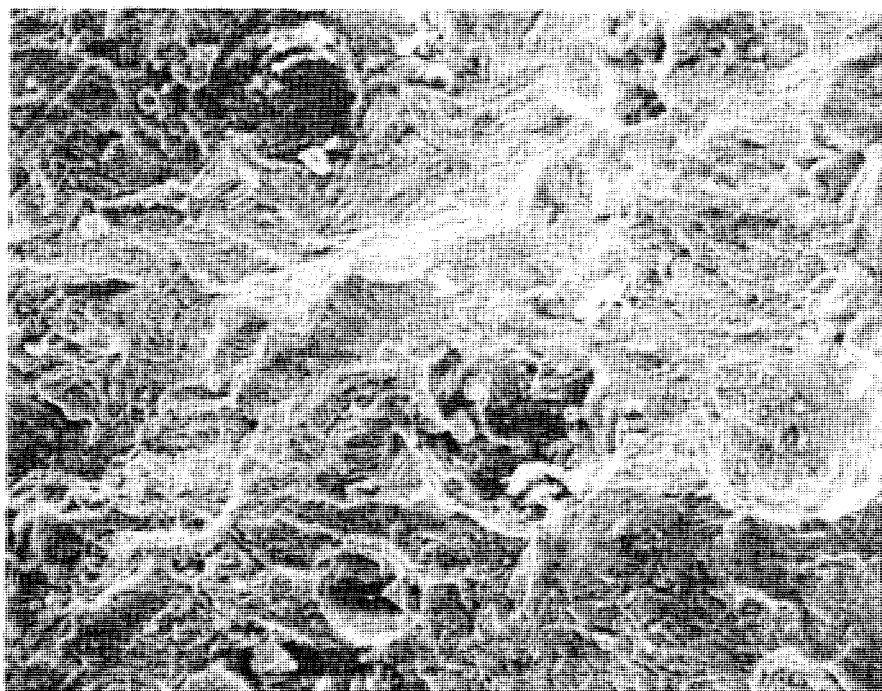
FIGURE 26 SEM showing representative morphology of a less corroded region of the fracture surfaces. Mag . 500x.

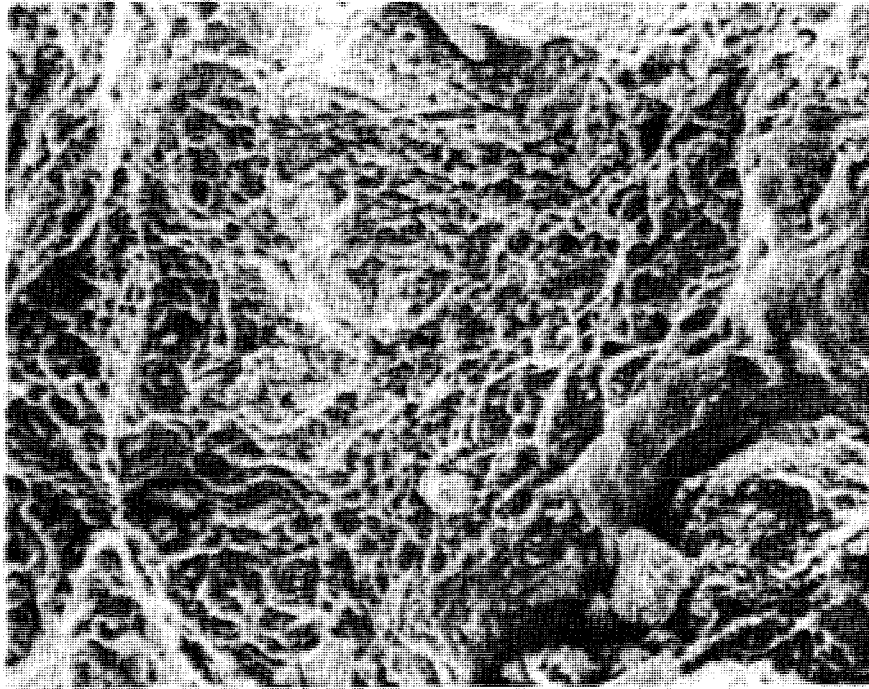
FIGURE 27 SEM showing area of ductile dimples suggesting overload failure. Mag. 2000x.

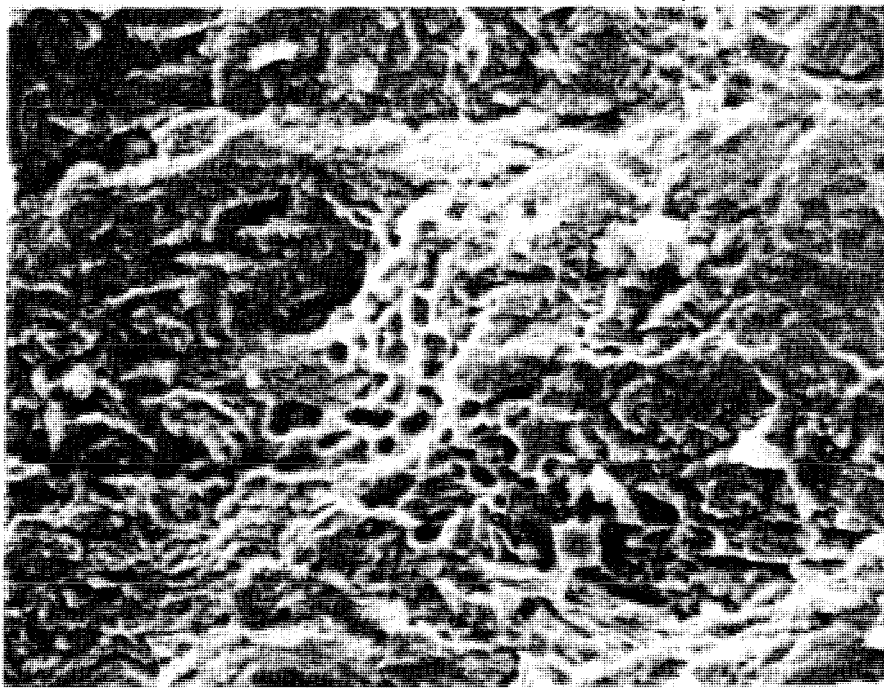
FIGURE 28 SEM of another area of ductile dimples noted on a less corroded region of the fracture surfaces. Mag. 2000x.

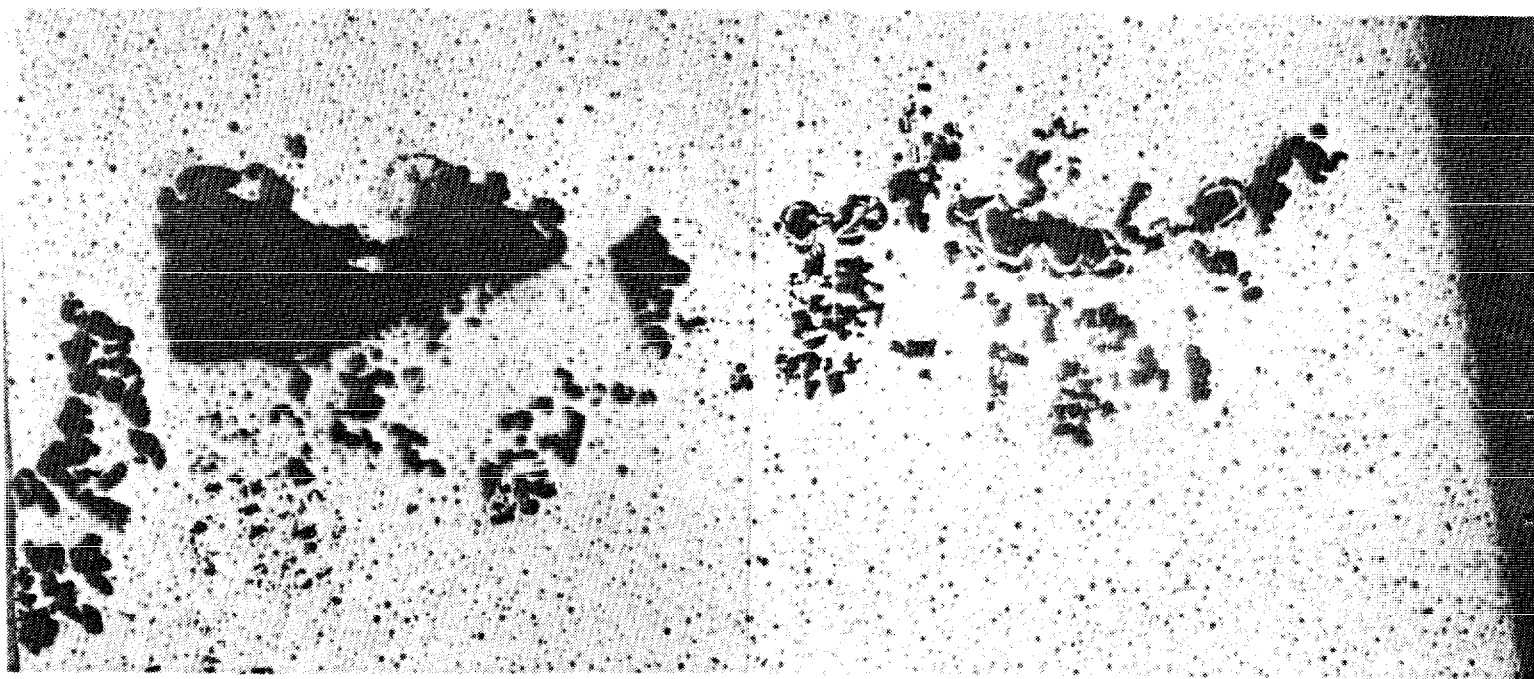
FIGURE 32 Large shrinkage cavity noted on track shoe #L30 metallographic specimen. Mag. 12.5x.

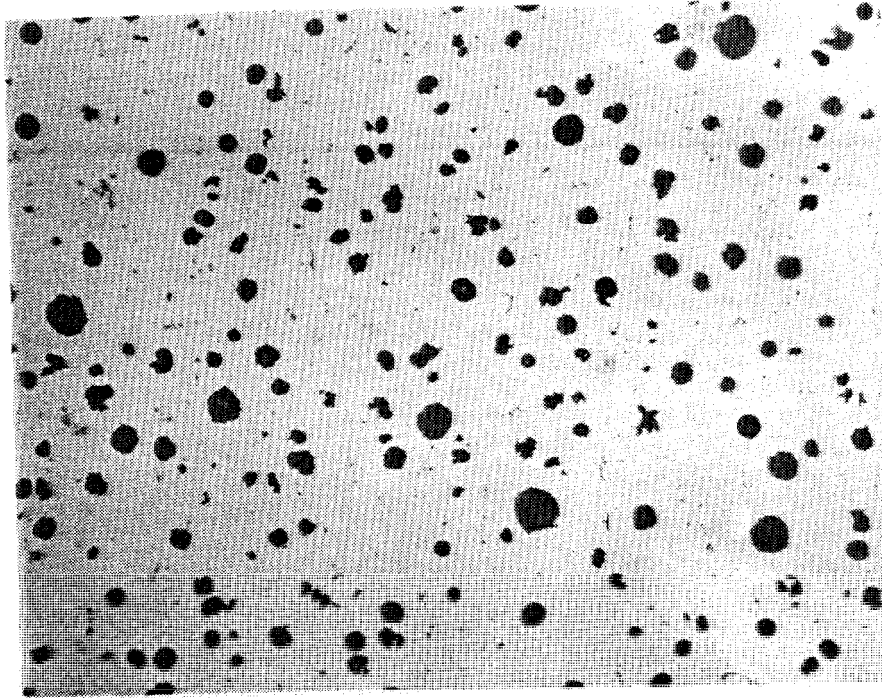
Regions representing "thin" and "thick" areas of the casting were sectioned from each of the failed track shoes and prepared for metallographic examination, as shown schematically in Figure 31. This diagram shows a total of eleven samples which were sectioned from a portion of failed track shoe #L30 for metallographic samples and retained austenite measurement samples. Similar specimens were sectioned from track shoe #R6. Examination in the as-polished condition and at low magnification (12.5x) revealed a very large shrinkage cavity within a thick region from track shoe #L30, as shown in Figure 32. The graphite spheroids were shown to be evenly distributed within the matrix (Figure 33). The nodules differ in size significantly which suggests that some may have formed early in the casting process while other formed later by post inoculation. However, the difference in sizes could also be due to a "slicing effect", in which different portions of the randomly distributed nodules were sectioned. In addition, some flaked nodules were noted. In excess, these irregularly shaped nodules are undesirable, since the larger surface to volume ratio raises the notch sensitivity and lowers the fatigue and impact resistance of the casting. Figure 33 was used to classify the graphite size per ASTM A 247 [3], *Method for Evaluating the Microstructure of Graphite in Iron Castings*. The average graphite dimension measured was within the 5-6 size class. The average nodule count measured from three samples of each track shoe was approximately 132 per sq. mm. nodules, which is considered acceptable, although slightly less than optimal for Grade 150/100/7 CAD1.

FIGURE 33 As-polished representative microstructure of a CAD1 sample, showing the graphite nodules. Nodule count was determined to be 132 per sq. mm., while nodule size was approximately 5 to 6, according to ASTM A 247. Mag. 100x.
